# Principles and Working of Automated Reformer Tube Inspection System ARTiS

TCR Advanced Engineering Pvt Ltd,  
Vadodara India

TCR Engineering Services Pvt. Ltd.,  
Mumbai India

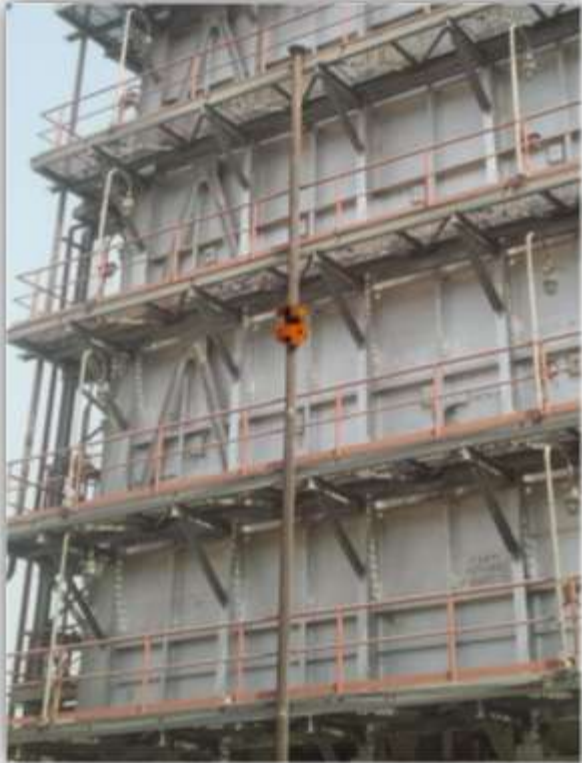
The primary reformers are used in various industries like fertilizers, petrochemical and refineries, for cracking of hydrocarbons in presence of nickel based catalyst in reformer tubes.

The reformer tubes are operational at 800+ °C temperature and are internally pressurized.

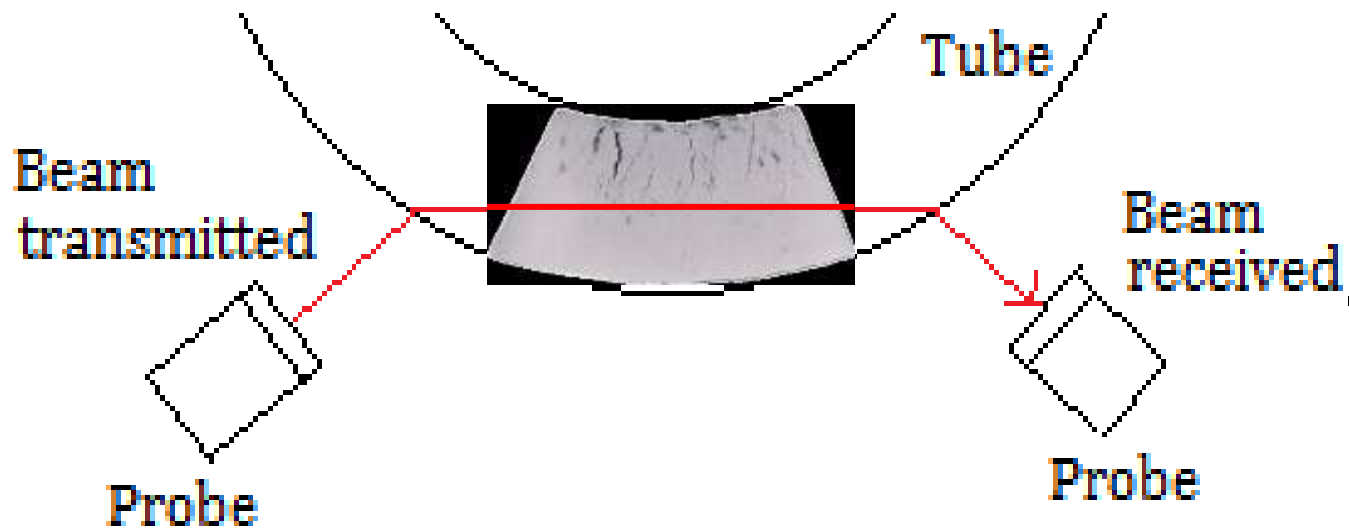
The ultrasonic inspection of reformer tubes is done in T-R (Transmit-Receive) mode where ultrasound energy is transmitted from one sensor, passed through middle of the wall section and received at other sensor (Figure 1). The energy transmitted is the sum of energy received and the energy lost in beam scatter.

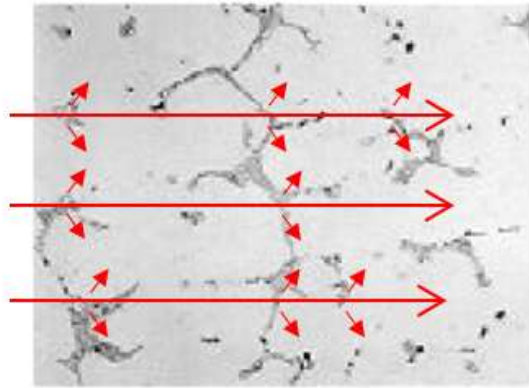
As cast condition

In as-cast condition, ultrasound scattering occurs at dendrite boundaries from primary carbides.

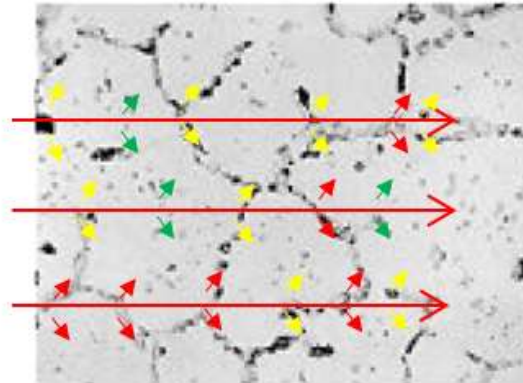
Having affected of creep damage

After prolonged exposure to high temperature, precipitation of secondary carbides and creep void formation additionally scatters the ultrasound.

The additive effect of beam scatter becomes the measure of energy lost.

Beam scatter at:

Dendrite boundary
-

Secondary carbide precipitates
-

Creep voids

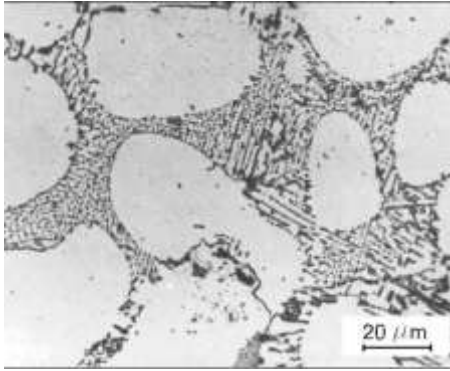
The microstructure of unused tubes is shown in Figure left, having dendritic columnar austenite grains oriented perpendicularly to tube walls.

Attenuation level: 35 – 55 dB

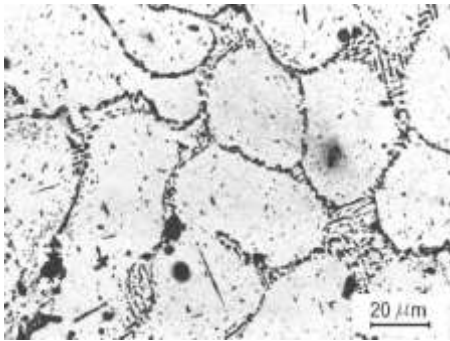
Upon aging, the structure degrades. The original morphology of eutectic carbides gets modified after exposure at elevated temperatures.

Attenuation level: 55 – 62 dB

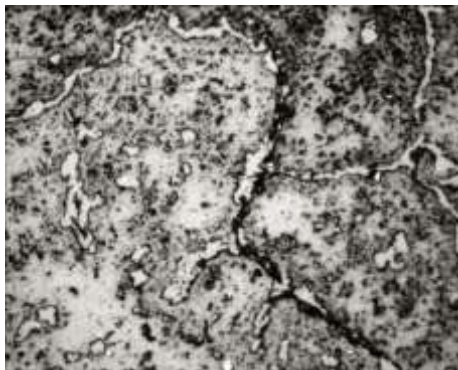
At life fraction near to 80 - 95%, the microstructure is coarsened secondary carbides with presence of inter dendritic micro cracks.

Attenuation level: 62 – 72 dB

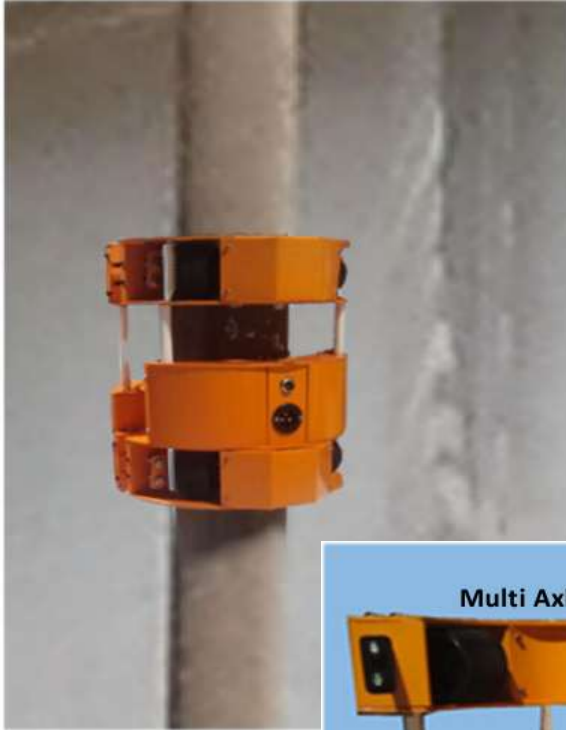
The crawler is powered by 4 metal gear motors, with total capacity of 200 watts.

Rubber padded shoe assembly carries the ultrasound sensors for T-R mode inspection.

IR Sensors provide diameter measurements.

This is a robotic crawler that aids ultrasonic testing of reformer tubes in more systematic manner and provide tabular output.

The sensors fitted on the crawler measures the tube diameter. During crawling, the diameter is measured at fixed interval of distance.

The gyro-sensors fitted on the crawler aids for angular measurements. Post analysis of angles would give quantitative figure of bowing.

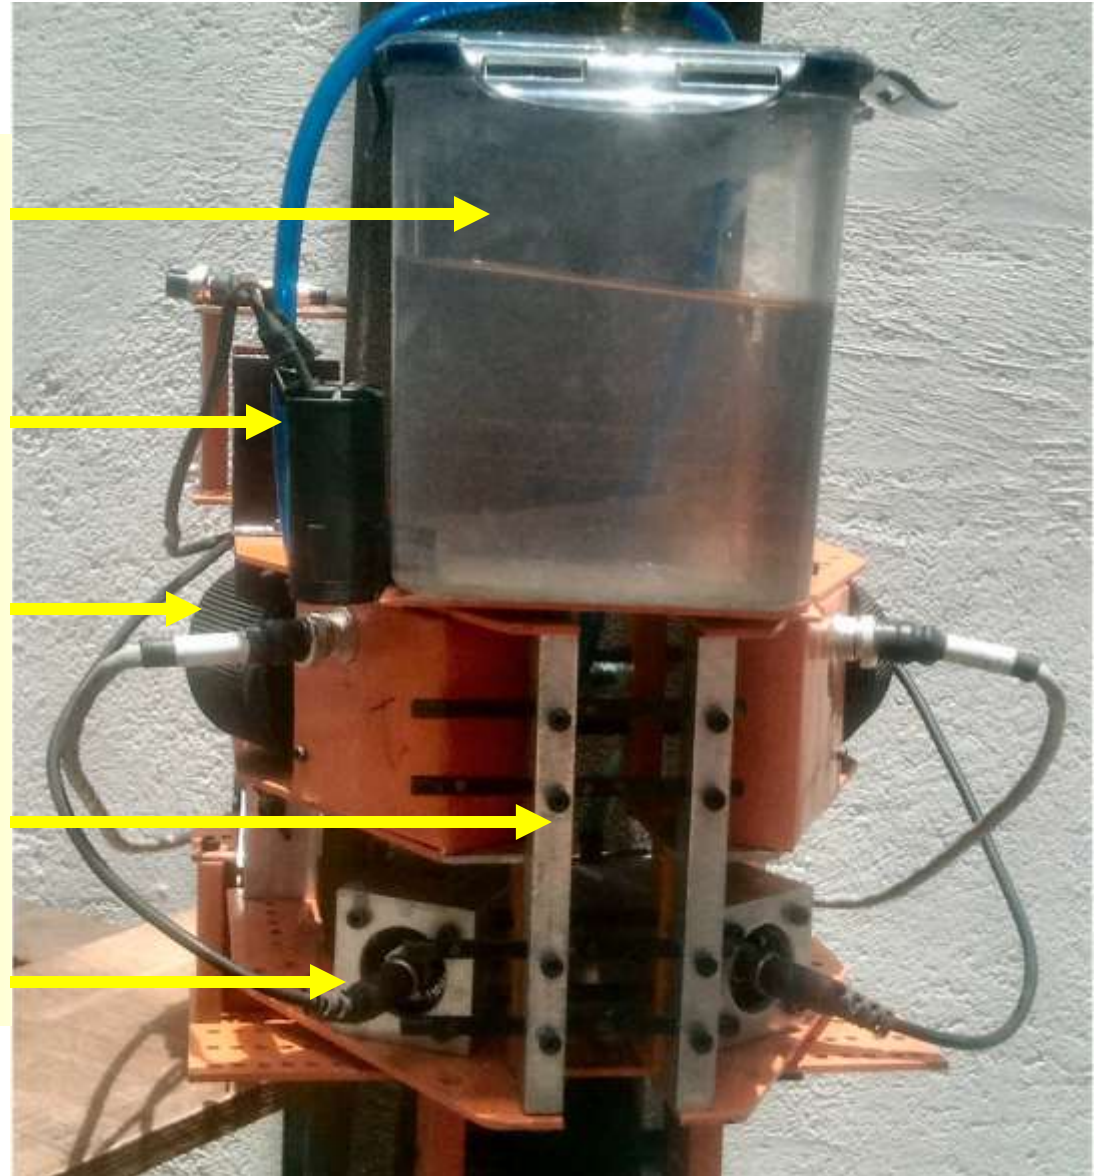
- Water tank for coupling
- Water pump
- Motors
- Adjustable arm
- UT Probes
