Remaining Life Assessment (RLA) of Power Boiler

TER Engineering
Services

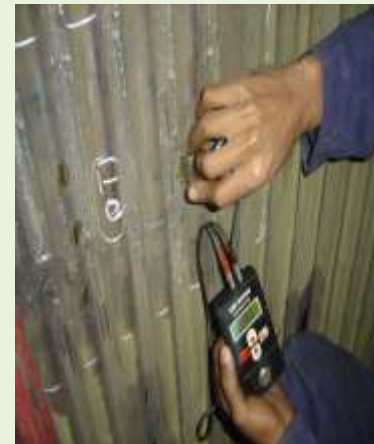
Thickness measurements of water wall tubes furnace

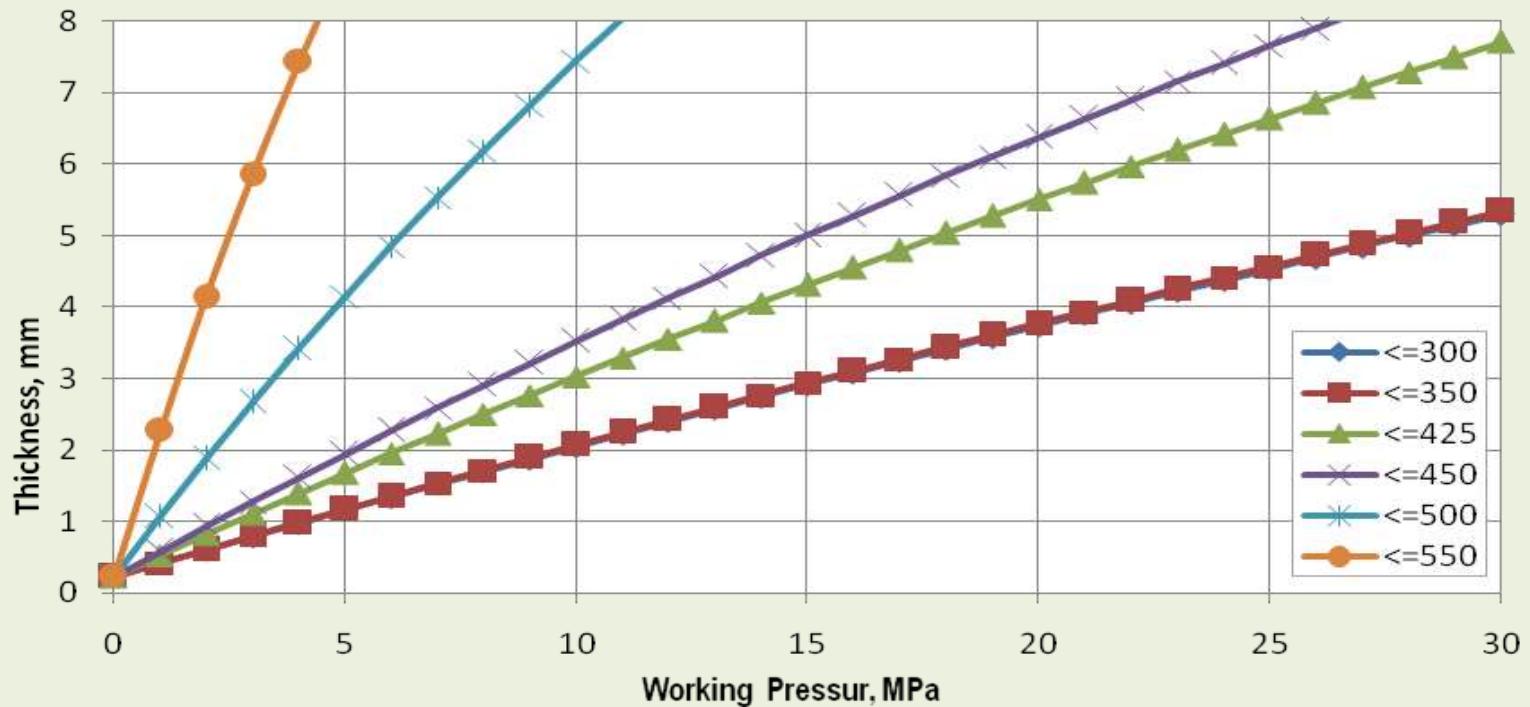
Minimum req. thickness for SA178-C

Minimum required thickness for different working conditions for materials SA178-C

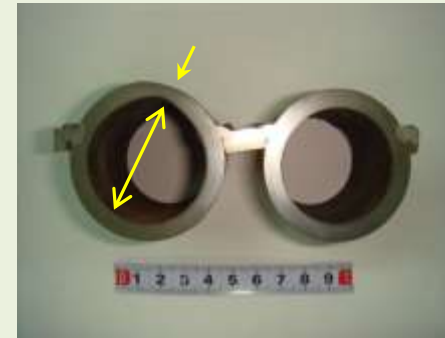
Thinning of bulged zone

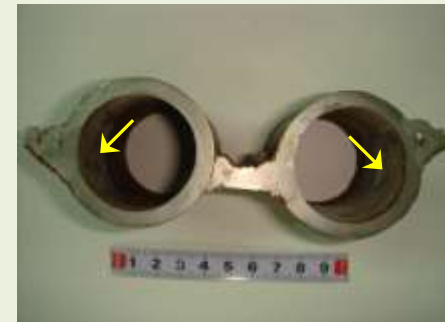
Internal surface scale

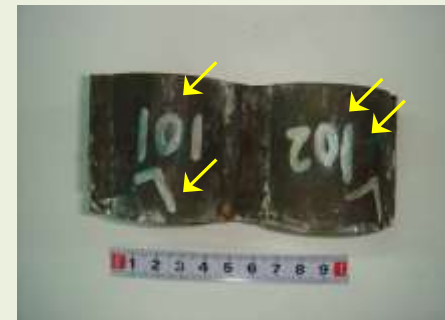
External surface scale

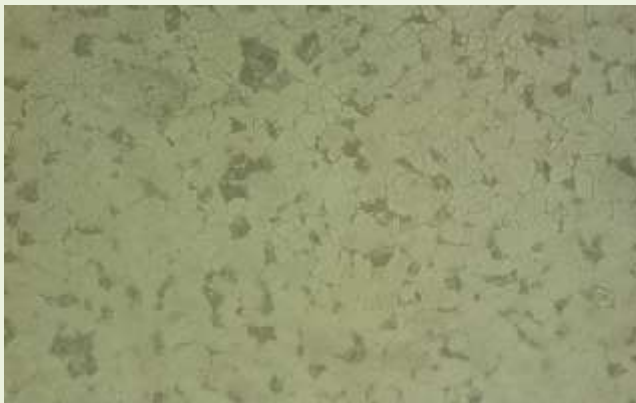
Normal Microstructure (good condition tube)
Which shows a typical ferritic pearlitic structure

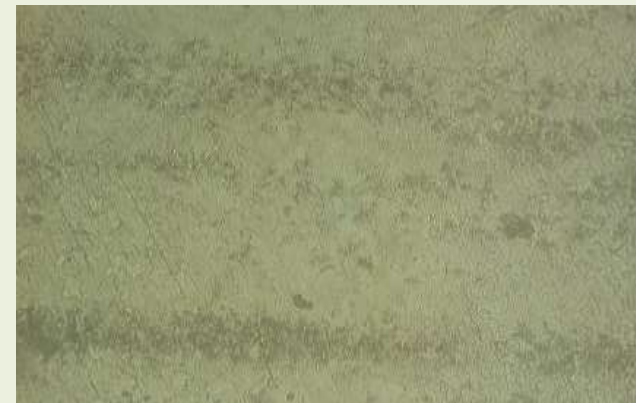
Deteriorated Microstructure which shows the
decomposition of the pearlitic colonies

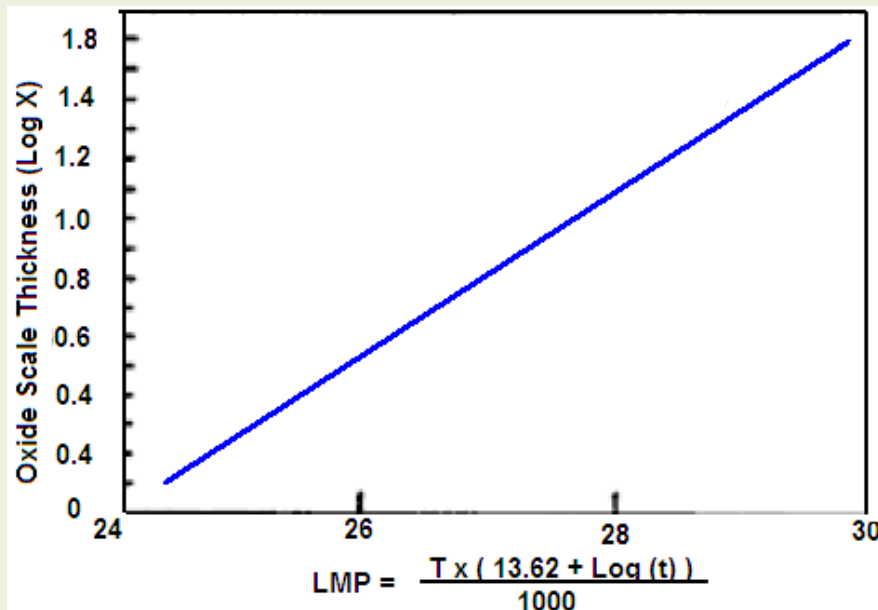
Chart 1,

- Growth of Oxide Scales is a function of Time and Temperature
- For Carbon Steels up to 3% Cr following Charts Apply
