OPTIMISING TUBE LIFE

Paresh Haribhakti and Ketan Upadhyaya, TCR Advanced Engineering, India, look at operational control for the enhancement of tube life and the role of automated reformer tube inspection.

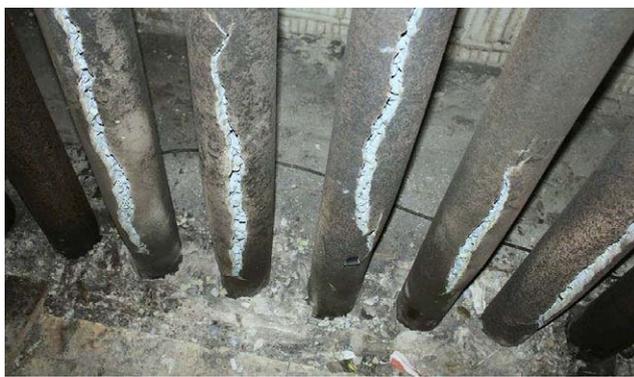
Figure 1. Multiple reformer tubes failed in a side-fired furnace design due to thermal shock/flame impingement.

The tubes are vulnerable to failure when subjected to a direct flame impingement because of mis-firing/uncontrolled firing of the burners. This can result in multiple failures of tubes that were subjected to impingement

Similar to direct flame impingement, temperature fluctuations in the furnace zone, either by power dips or due to process upset condition, also give rise to multiple tube failures. The typical failures of reformer tubes are shown in Figure 1. The condition of the burners needs proper inspection during available turnaround opportunities to ensure their functionality.
